Eyes on the Tsolum River Year 2

Summary of July 2023 Observations

Summary of the Eyes on the Tsolum River Observations in July, 2023

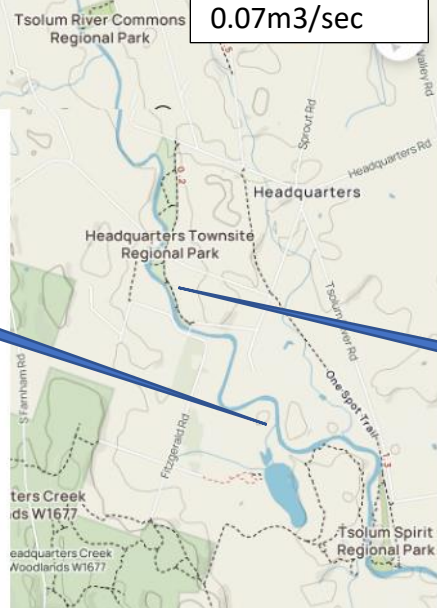
Lots coho fry
start of July.
Very few at end
of July Resident
Mink evident.

Multiple Refugia mapped in this stretch. July 14 to end of July.

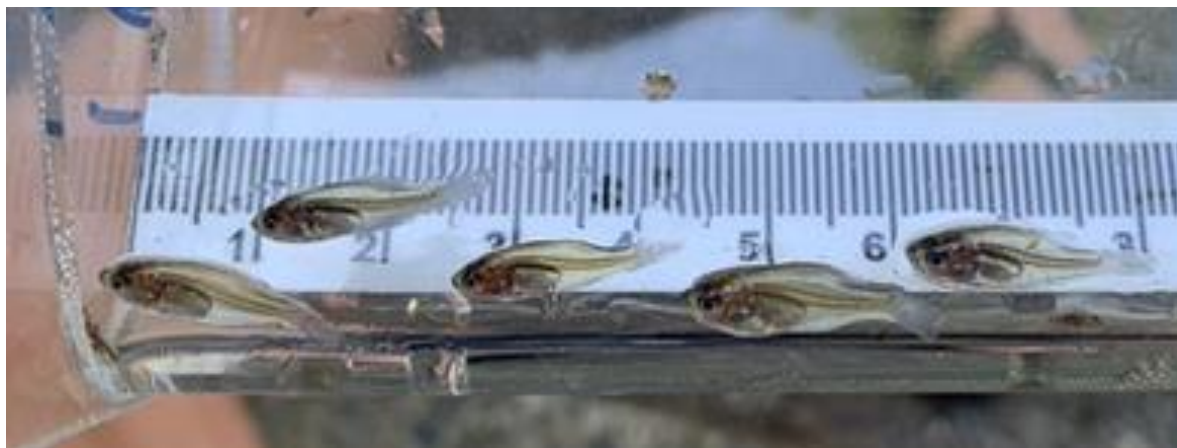
To date, no larval size young of the year (YOY) Pumpkinseed Sunfish, (like the fish in the picture following), have been reported captured in nets in the main stem of Tsolum River. This indicates that they are possibly still only spawning in the Wildwood Marsh and other connected ponds connected to Smit Creek.

ETR observations in June determined that 0+ and 1+ PSs had migrated in high numbers into the lower Tsolum. It was therefore concluded that, with this invasive species, we are now gone from an eradication to a containment strategy.

Just recently an interdisciplinary team met to discuss how to contain these fish. It was decided at this meeting to install a containment fence in Smit Creek closer to the confluence of the Tsolum River, before the fall rains arrive. This is necessary because, so far, the PS spawning nest sites have not been located.

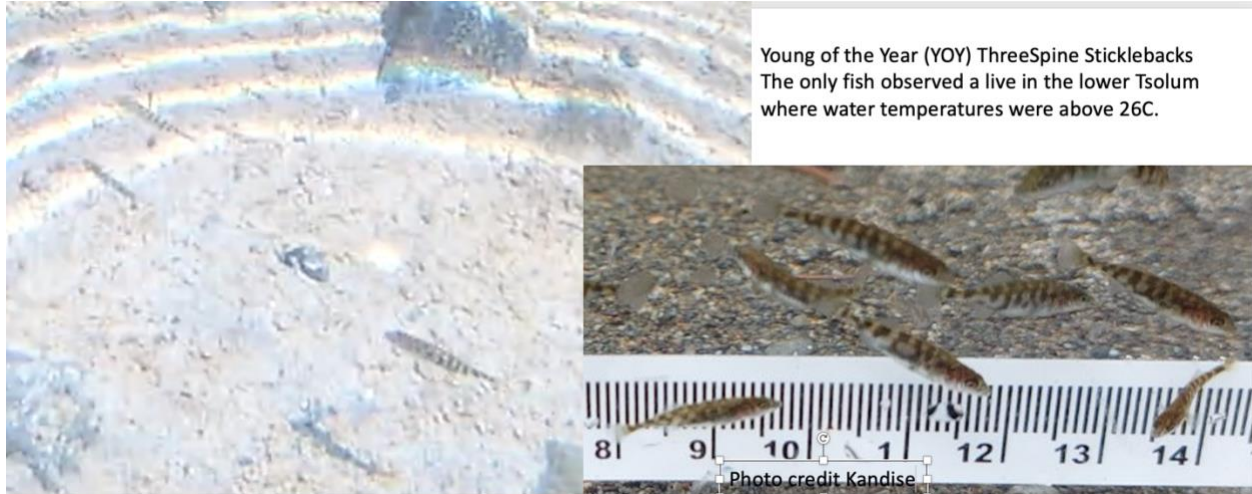
As in the previous two years, dead and diseased juvenile salmon and trout were observed, especially in areas in stretches that had little no tree canopy or riparian zone, where water temperatures were lethal. As a result, by the mid July in the barren open stretches of the mid to lower Tsolum, only the occasional small schools of young of the year (YOY) ThreeSpine Sticklebacks were observed.

Due to the very low flows, the “wetted width” of the main stem Tsolum to only a few meters wide in many areas and, consequently many fish were stranded in isolated, drying pools and side channels.

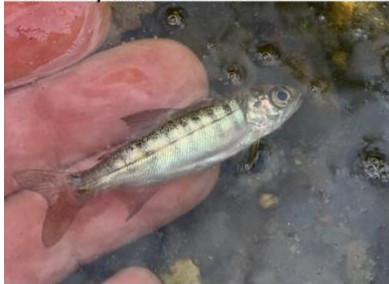
Recently dead Coho succumbed to heat stress

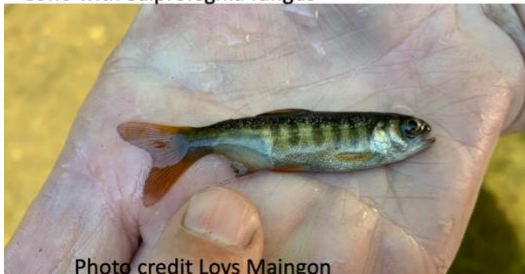
Coho with Salprolegnia fungus

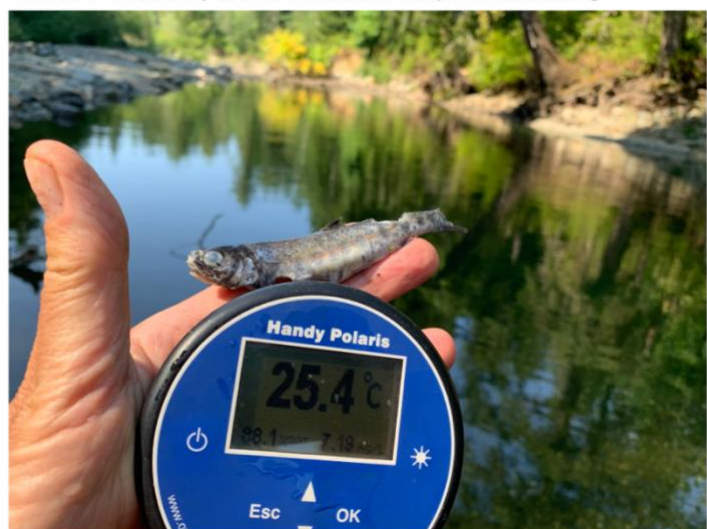
Rainbow trout likely died of heat stress the previous evening

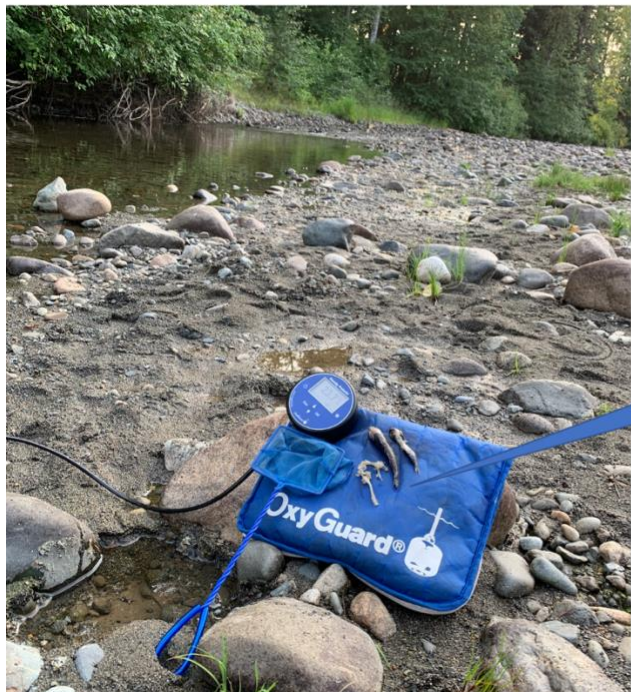
Carcasses of sculpins that were, most likely, partially eaten by crayfish.

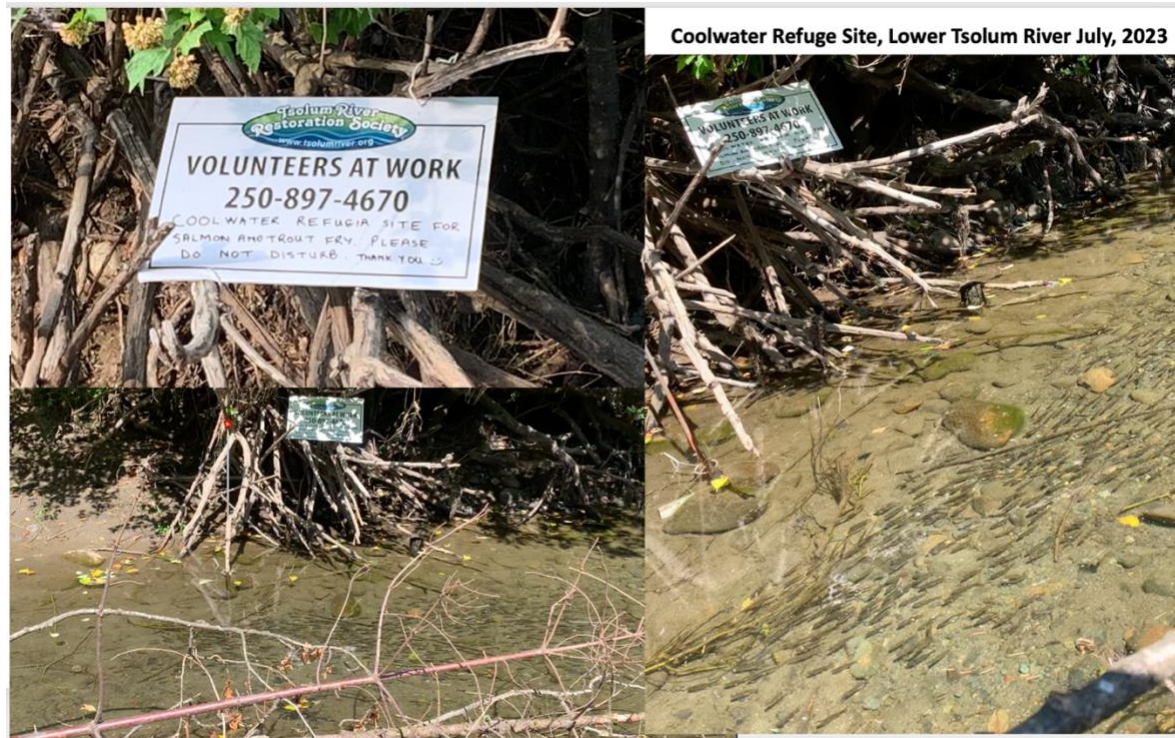
This same refugia in the Lower Tsolum is being monitored again this year In an attempt to increase salmon survival at this refugia, small woody debris (SWD) tree cover and signs warning to notify walkers of this sensitive area, were installed.

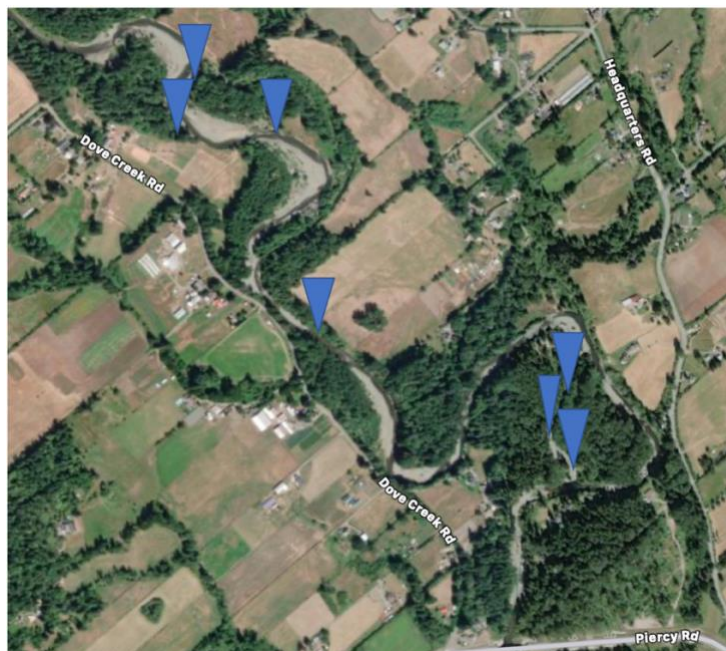
Cool water Refuge Sites Mapped in 2023:

ETR observers this year have increased their monitoring of refugia sites in one stretch of the Lower Tsolum and noted the coordinates and estimated fish densities (see Appendix 1. July observations).

3 upstream sites: A total ~ 800 juvenile salmonids, see July 14, SC

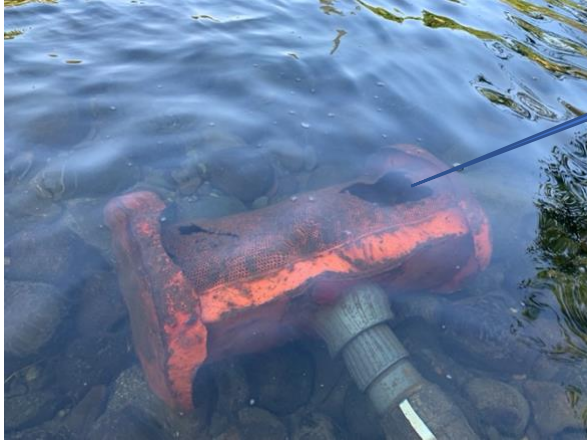
As flows and water levels dropped, some water users moved their intakes closer to deeper channels (Thalweg), possibly making the intake screens are more prone to mechanical damage.

To safe guard against salmon smolts and fry getting suck in the pump, especially when pumping at night, water users please inspect intake screens regularly.

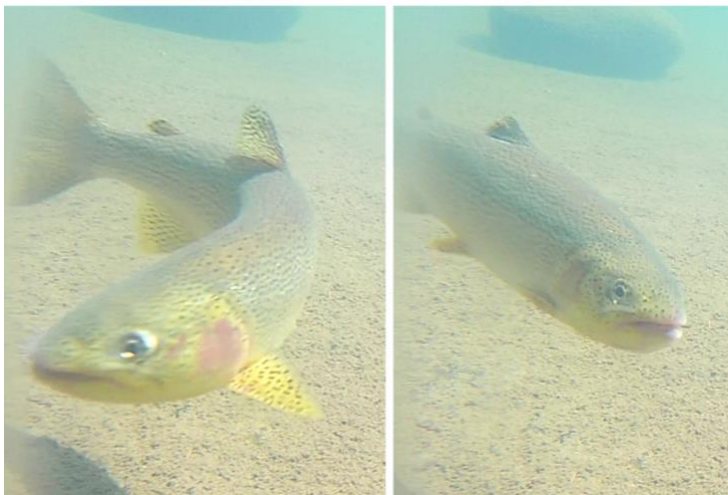
Recently, there has been a number of sightings of large ~ 2ft (60cm) salmonids in the mid stretches of the Tsolum. This prompted a few ETR persons to keep an eye out for these fish. In July, after two or three large fish were regularly seen in one location, a GroPro camera was set up at the sight for couple days, and we were fortunate to a 2 second glimpse of one fish (see pictures following).

After sending the mini video clip and stills of this fish around to a few persons, the consensus was that it is possibly a sea-run cutthroat trout or Cut/Bow, a hybrid between a cutthroat trout and rainbow trout.

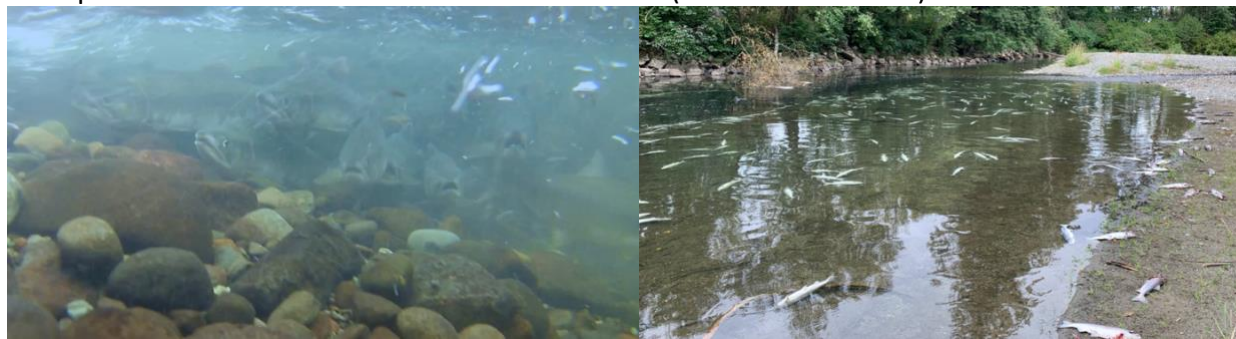
Low flows and low water levels in late August and early September caused migrating Pink Salmon to stack up downstream of barriers such logjams and isolated pools. Because of the very high fish density behind these barriers, the dissolved oxygen dropped to lethal levels, asphyxiating 1000s of adult Pink Salmon and some juvenile salmonids (Chamberlain 2022).

Example of Pink Salmon Kills in a Bottleneck in 2021 (Chamberlain 2022).

Fortunately, ETR folks reported these bottlenecks early, and a tunnel was made in the logjam and channels were dug between isolated pools, freeing to fish to move further upstream. This averted subsequent massive fish kills as 1000s more Pinks that were downstream, immediately behind these fish. Fortunately shortly after these fish kill events, the rains came, enabling this fish to spawning throughout the watershed in October 2021.

To be more proactive this year the DFO water management team has asked ETR to locate potential logjams that could prevent fish passage and possibly tunnel them before significant number of Pink Salmon move upstream in late August. Personally, I do not the equipment or expertise to do this work but would gladly assist anyone who has?

The digging channels between isolated pools however, is best to done once fish are stacking up in the lower pools, to prevent the possible of premature de-watering of upstream pools before the rains come.
