## TSOLUM RIVER RECOVERY PLAN: TSOLUM RIVER WATERSHED

(Version: AUGUST 2016)

Sylvan Island Environmental Consulting  
Angela Spooner, MSc  
6421 Rennie Rd, Courtenay, BC V0J 1V1

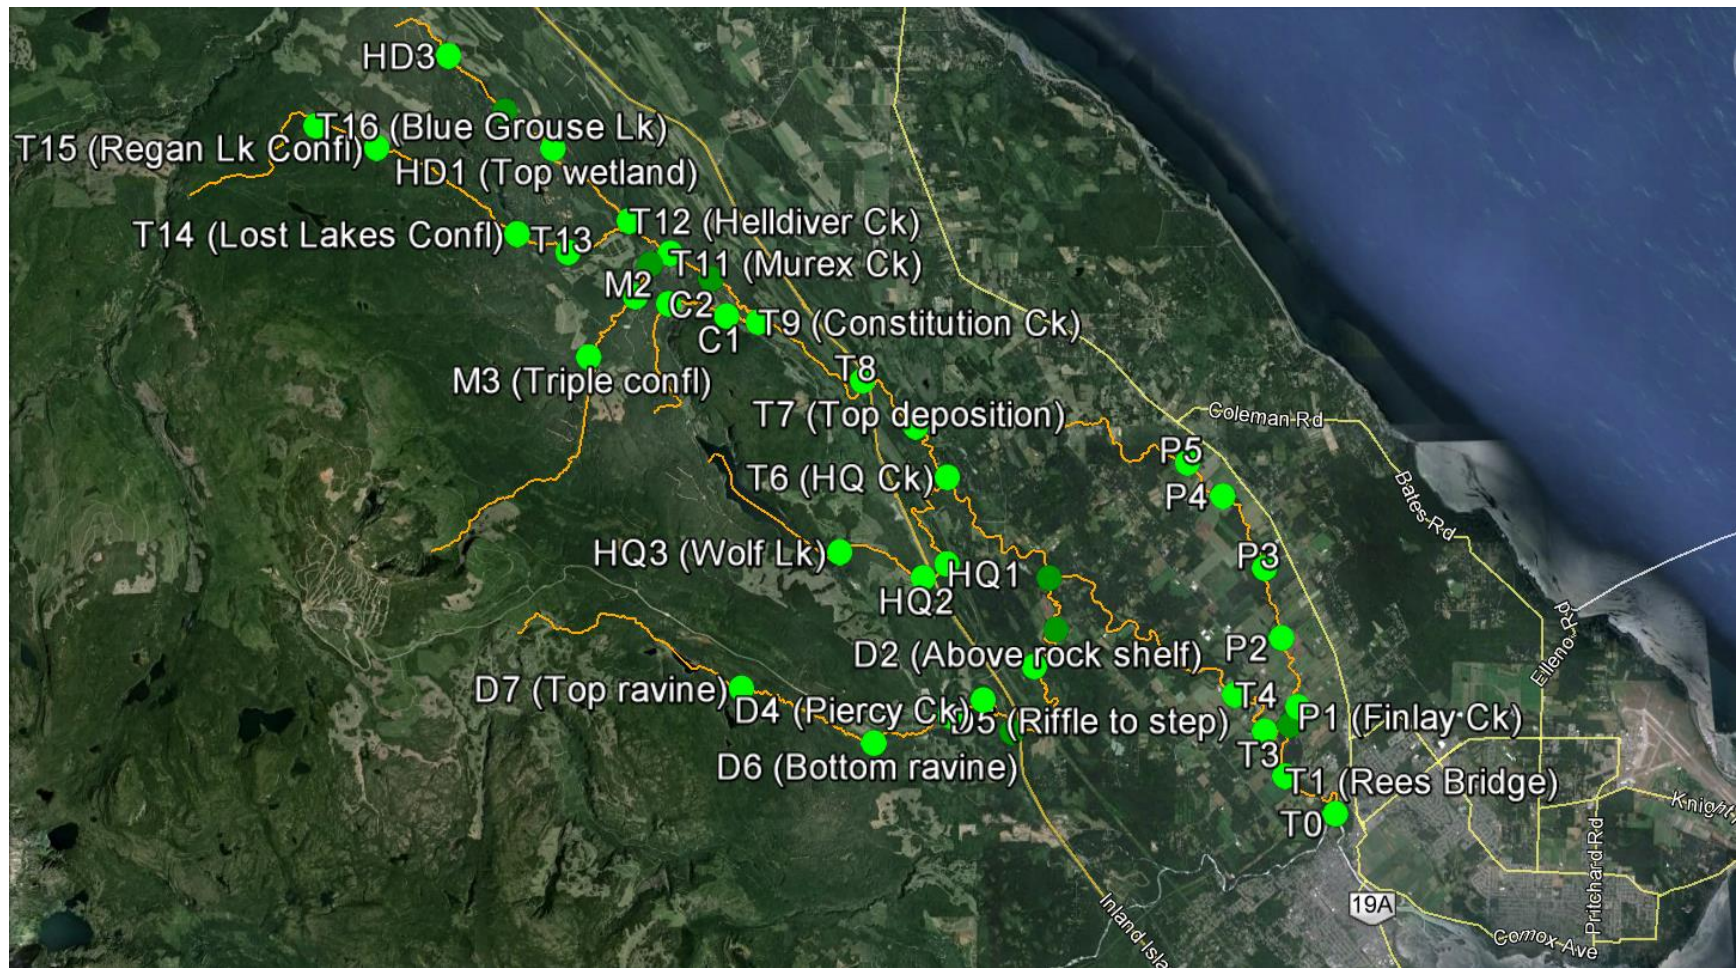
Figure 3 – Tsolum Watershed showing Reach Designations (from the TRRS Mapping Tool at [www.tsolumriver.org](http://www.tsolumriver.org))

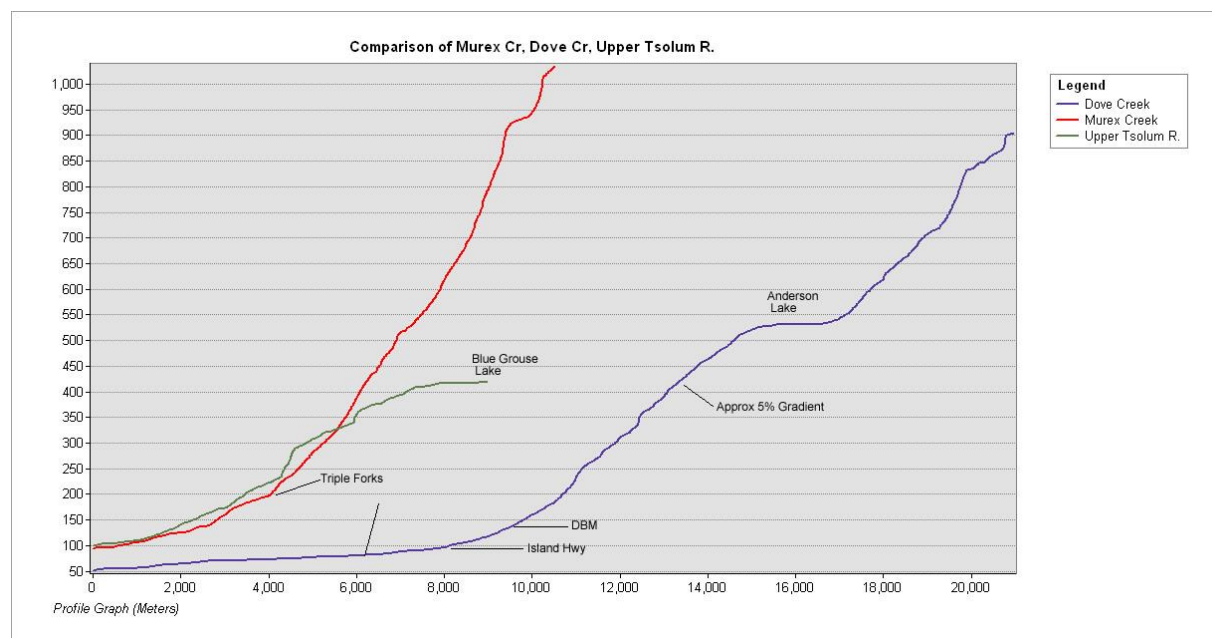
**Figure 4 – Gradient profiles of Dove Creek, Murex Creek and the Upper Tsolum**

The Tsolum Watershed includes many significant (3<sup>rd</sup> order or greater) salmon bearing tributaries; Dove, Murex, Headquarters, Hell Diver, Constitution and Portuguese. There are many other smaller stream channels in the watershed which are identified on the community stream atlas (Project Watershed SHIM, 1999-2005). The Tsolum watershed consists of a long low gradient mainstem along the base of Mount Washington from Helldiver Lake to the Puntledge confluence, with the steeper headwaters (upper Tsolum) and tributaries (Murex Creek, Headquarters Creek, and Dove Creek) entering the low gradient Tsolum off of the side of the mountain. Downstream on the floodplain, Portuguese Creek brings in flow from the flatter, low elevation agricultural land on the east side of the river (Figure 4).

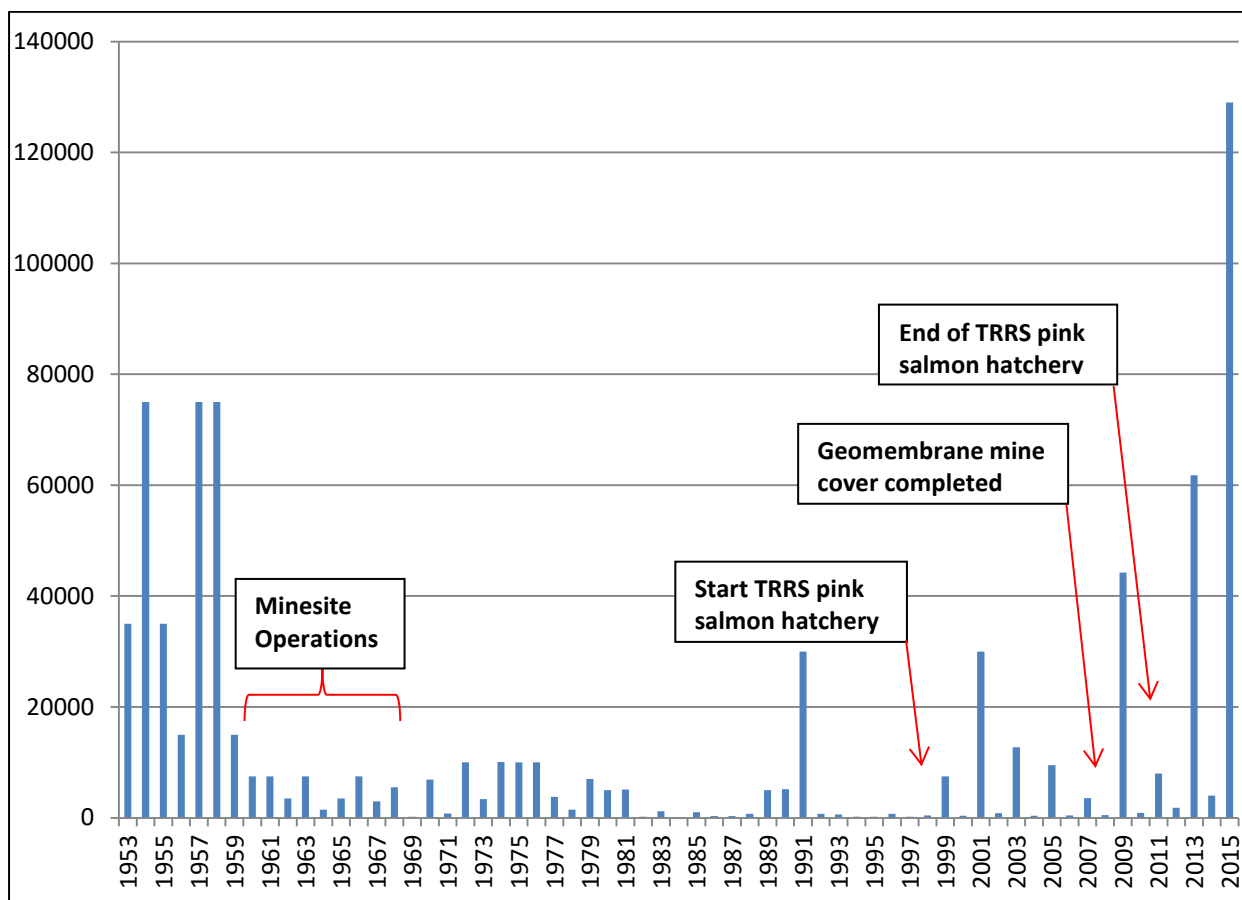
Figure 5 - Tsolum River Pink Salmon Escapements 1952 – 2015.

Today, pink salmon are the dominant salmonid species in the Tsolum Watershed and both even and odd year pink salmon can be found in the watershed (Figure 5). The next most common species are coho and chum (Figure 5). Currently, all five species of pacific salmon are found in the Tsolum River watershed (Table 1). From Fisheries and Oceans escapement records (Mapster v3: <http://pacgis01.dfo-mpo.gc.ca>), pink salmon are the most abundant species with runs cycling below 1,000 up to over 40,000 until 2012. In 2015, the largest run single day count was approximately 129 000 fish in the Tsolum Watershed. Not only was this the largest run since the water quality remediation but the largest day count ever registered for the Tsolum with records going back to 1935 and the first non-enhanced (non-hatchery) run since pre-copper mine days - the last fry release from the Tsolum Hatchery was in 2012. A cautious victory since this population remains vulnerable due to many variables including: low flow levels, high summer water temperature, high fall/winter flows effect on bedload movement and riparian health and diversity resulting in loss of large woody debris recruitment, food availability and marine survivability.

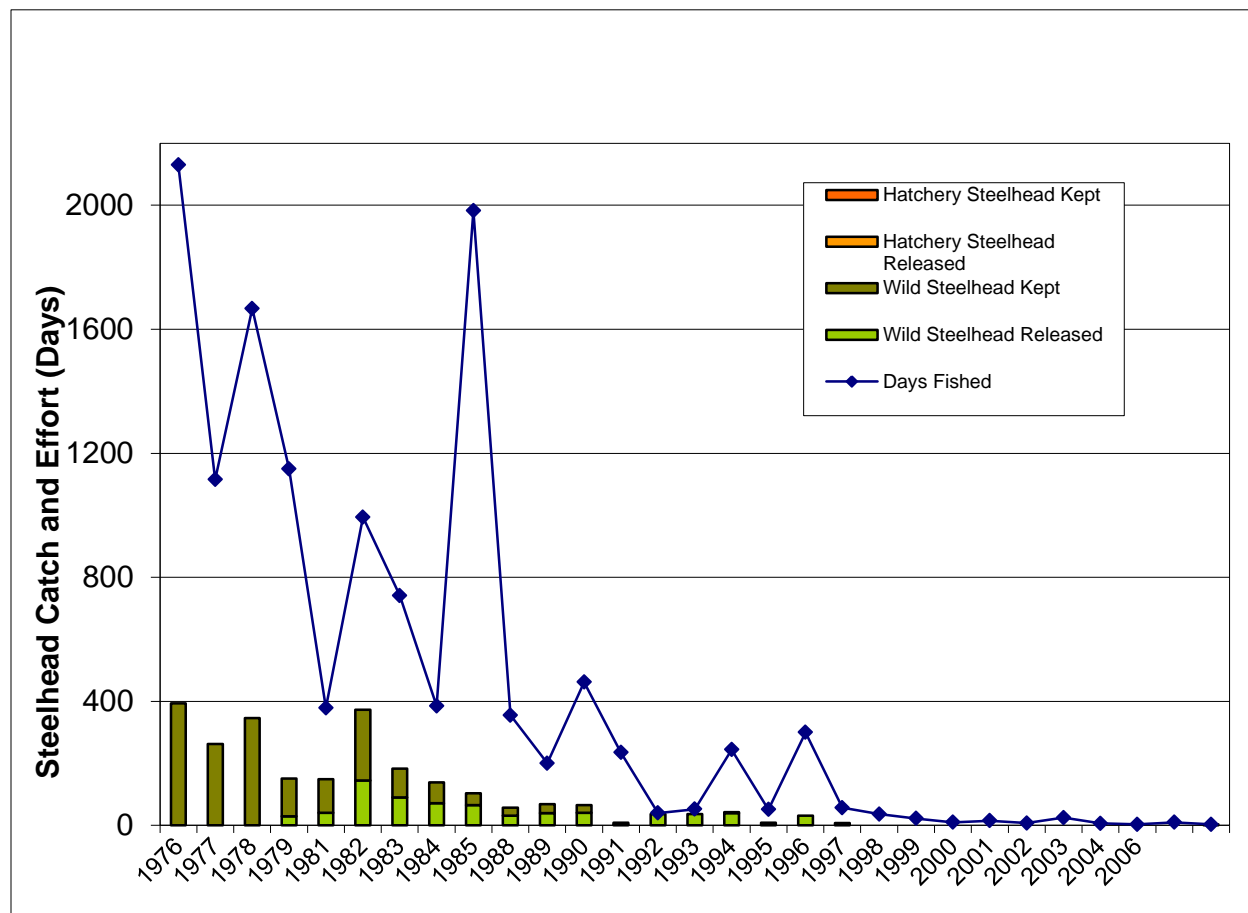
Figure 6 - Tsolum River Steelhead Catch and Effort, 1968-2008 (figure provided by BC Ministry of LNRO)

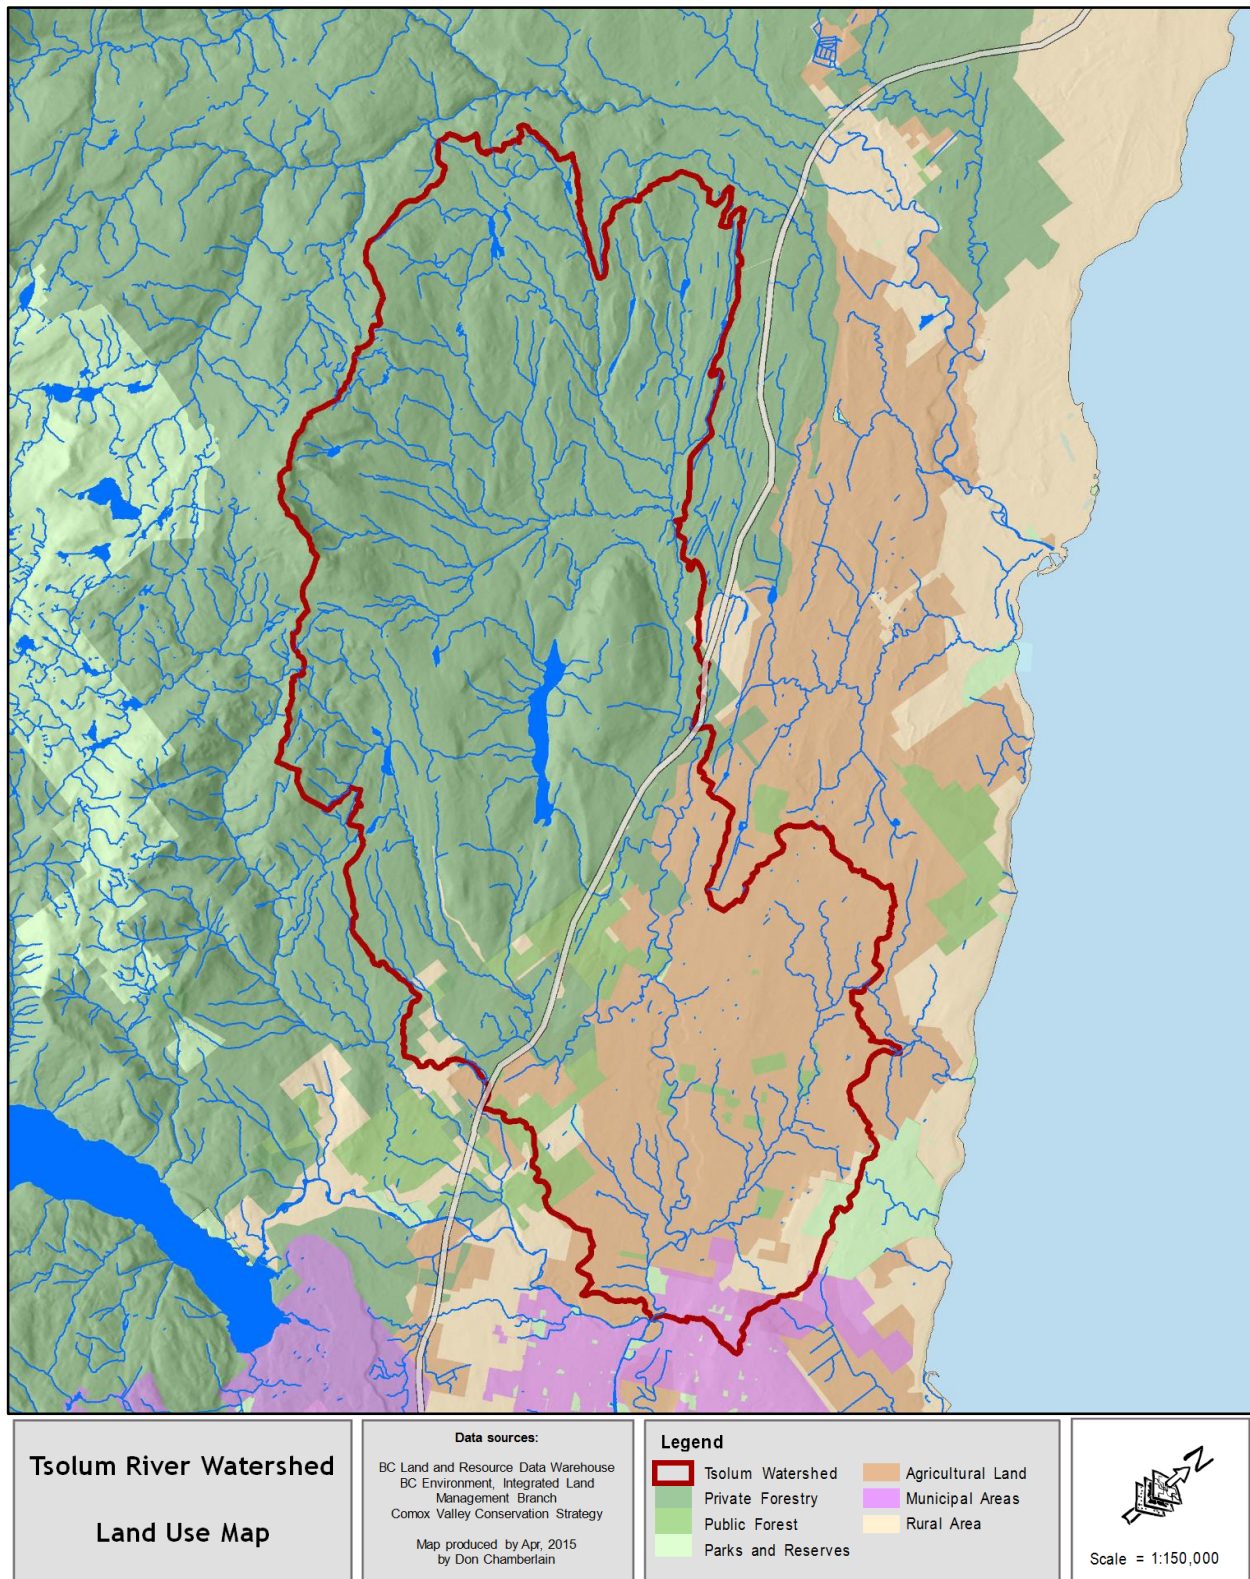
Figure 7 – Land Use within the Tsolum River Watershed

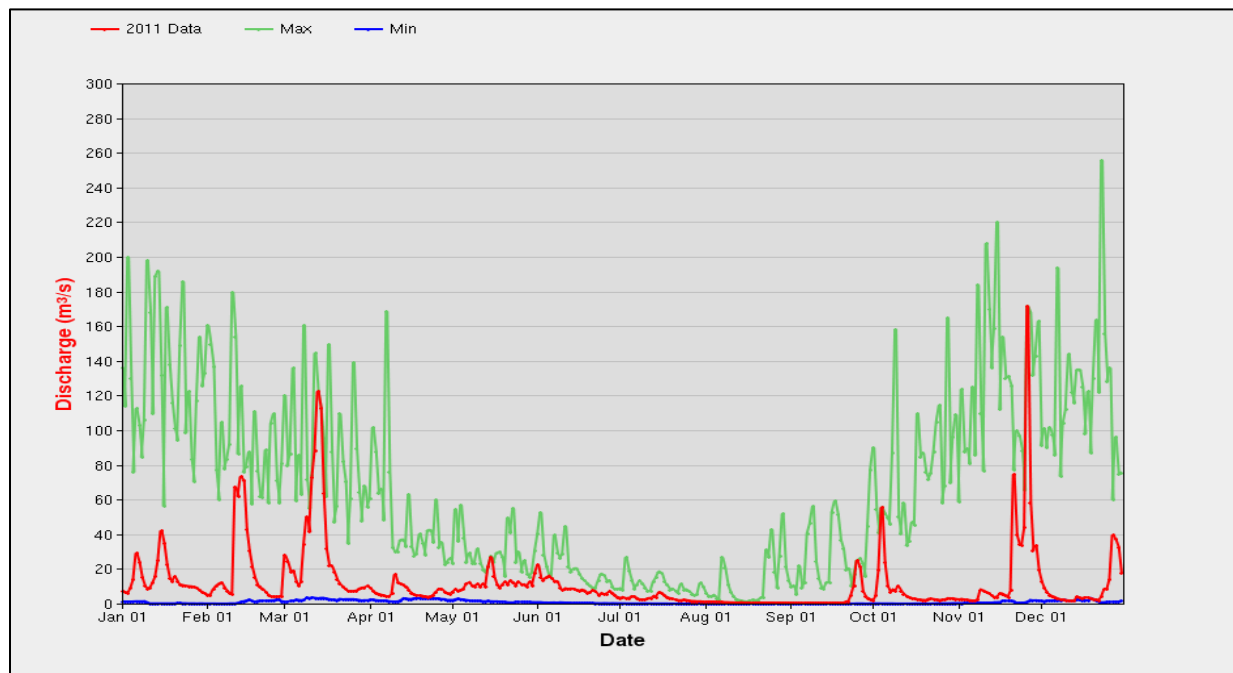
Figure 8 – Daily Flows at the Tsolum River Water Station - 2011

East Coast of Vancouver Island watersheds experience extreme fluctuations in flow, primarily resulting from rain events (Figure 8). There is a Water Services Canada (WSC) flow station on the lower Tsolum with real time results. Unfortunately a second station below Murex Creek is closing. The TRRS, under the guidance of BCCF, also does manual flow monitoring on the Tsolum River below the Dove Creek confluence, there is also a WSC flow monitoring site on Dove Creek. Data can be found in the *Tsolum River, Vancouver Island, BC Hydrometric & Water Temperature Data Report, 2012-2015* (BC Conservation Foundation, 2016). The Tsolum River was captured under the Water Allocation Plan (Riddell & Bryden, 1996). This plan was to summarize the current and historical flows and allow for proper management. The goal was to conserve the quality, quantity and timing of water flow or prevent cumulative hydrological effects.

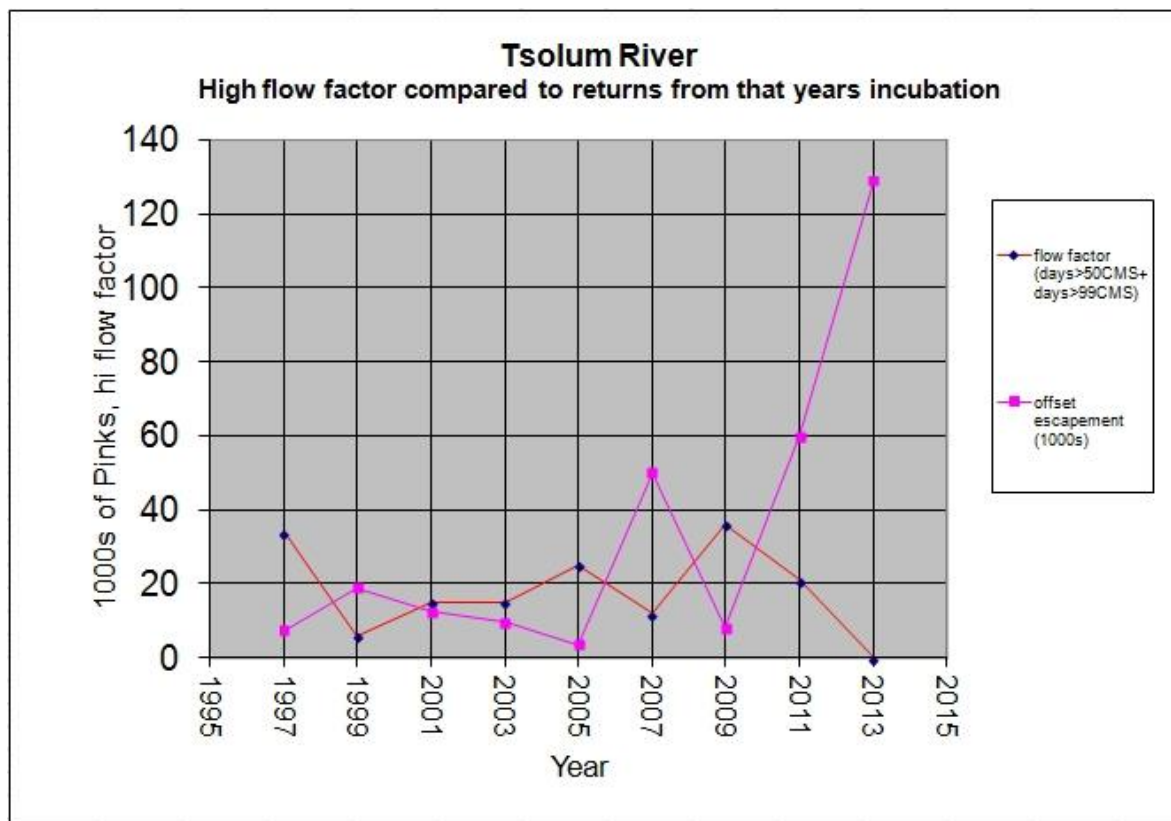
Incubating eggs and pre-emergent fry are vulnerable to the combination of high flows and unstable mobile bedload. Gooding (2015) reports if there are more than five days of greater than 50 cfs water flow rate days in a winter; the pink fry emergence will be severely, negatively affected (Figure 9). As a potential impact of climate change, frequent extreme weather events will make monitoring and recovery planning more challenging in the future.

Figure 9 – High Flow Factor versus Pink Escapement Curve, 1997-2013

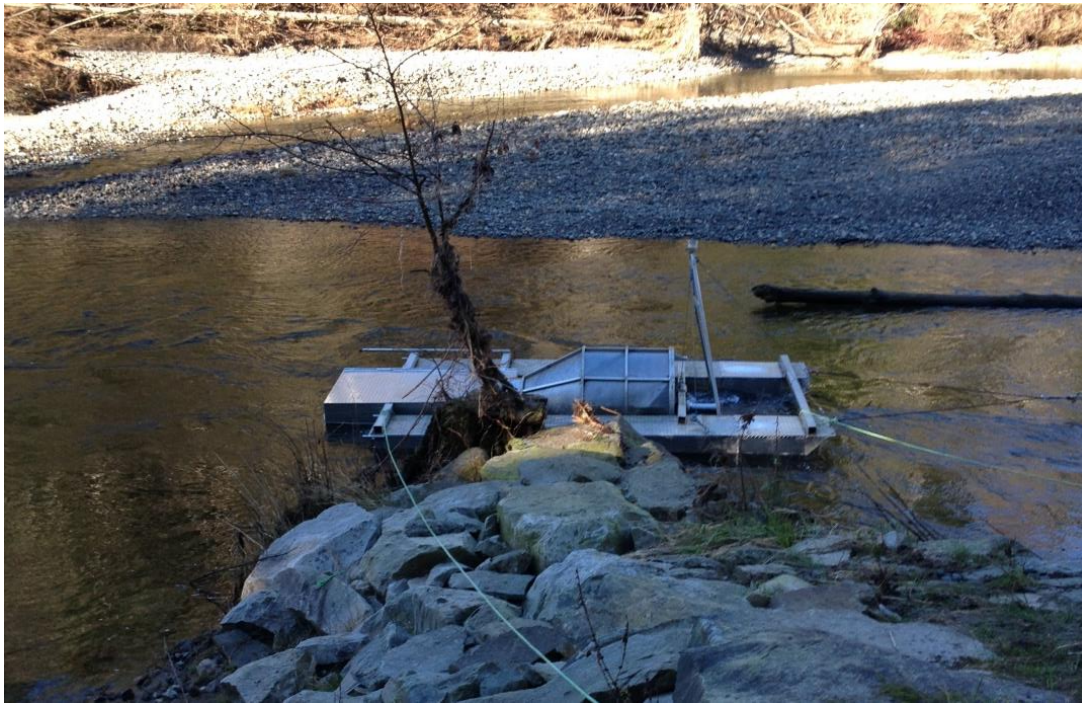
attached on either side. The cone is situated in the river such that the narrow end points downstream. Inside the cone are a series of angled baffles that spiral down the central shaft and cause the cone to rotate in the current of the river. As the cone rotates fish enter the trap and are guided into a holding box located at the downstream end. DFO contributes to maintenance costs of the TRRS owned RST. TRRS members and volunteers identify, count, measure and release the trapped fish each day. The TRRS RST is placed in the Tsolum River at T3 – Stephens Rd. from late March through early June.

Because RSTs only take a subsample of the total population, it is important to know what percent of the population the subsample represents. In order to estimate this, mark/recapture studies are commonly performed while the trap is running. A known number of fish are marked by colour dye and released upstream of the trap, and the number of marked fish subsequently caught downstream by the RST is recorded. The ratio of recaptured fish to number of individuals marked indicates the trap efficiency. Using the trap efficiency and the number of fish caught by the RST fishing days all can be expanded and a total population estimate can be made.

**Figure 10 – RST at Reach T3 - Tsolum River 2015. Photo credit A. Spooner, 2015.**

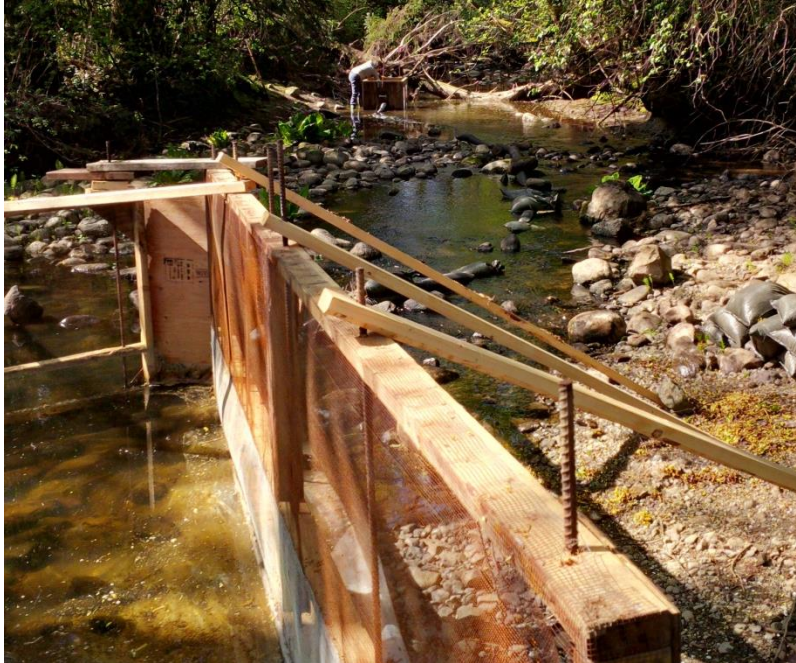
A common and effective method utilized for smolt enumeration is the full-spanning fence. A full-spanning fence is essentially a V-shaped weir that points downstream and funnels fish into a holding box where they can be identified, counted, measured, and released each day. The “V” is constructed with panels made of a 4’ x 8’ wood frame panel covered in hardware cloth. The size of the hardware cloth is such that water and most fry are able to pass through, but the smolts cannot pass through and are funnelled into a tube at the base of the “V”. Once the smolts enter the tube they travel downstream to a holding box for counting.

Full-spanning fences are desirable because they count every fish that migrates downstream. 2015 was the first year that the TRRS and it was found to be successful in terms of effort, volunteer resources and counting techniques (Figure 11). The TRRS reinstalled the fence on Portuguese Creek again in 2016 and added a second fence on Finlay Creek. After 4-5 years, the fences will be moved to other tributary locations in order to get a better understanding of smolt use in more creeks in the system. It is also possible to mark the smolts caught in the fence by caudal cut prior to release in order to get a better idea of RST count efficiency and proportion of smolts (expansion factor) that enter the mainstem versus staying in the tributaries.

**Figure 11 – Fish Fence Reach P1 – Portuguese Creek 2015. Photo credit S. Marcoux, 2015.**

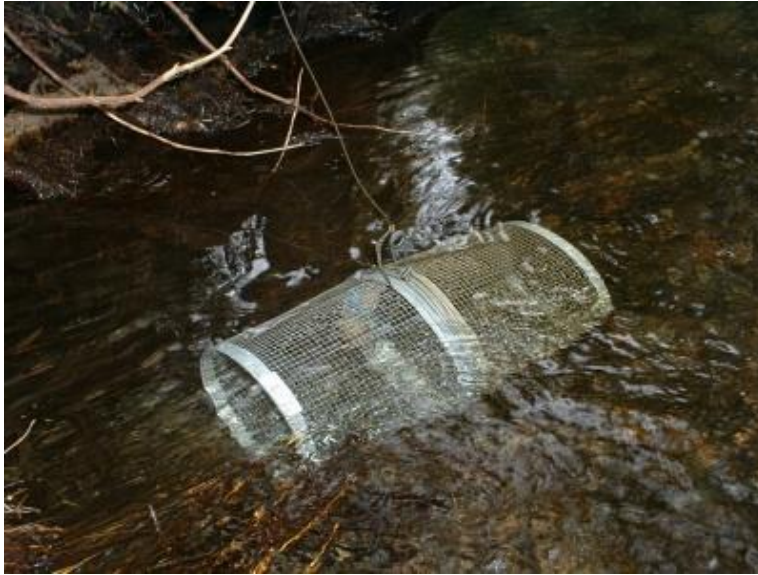
Gee traps (Figure 12) are used to sample fish use in the river and off channel habitats such as wetlands and side channels. They are a small basket trap that are baited with salmon roe and allowed to soak overnight to establish the fish use of different habitat features. The TRRS often uses these traps in their fry salvage efforts in low flow periods.

**Figure 12 – Gee Trap in a Stream ([www.byrnecreek.org](http://www.byrnecreek.org))**

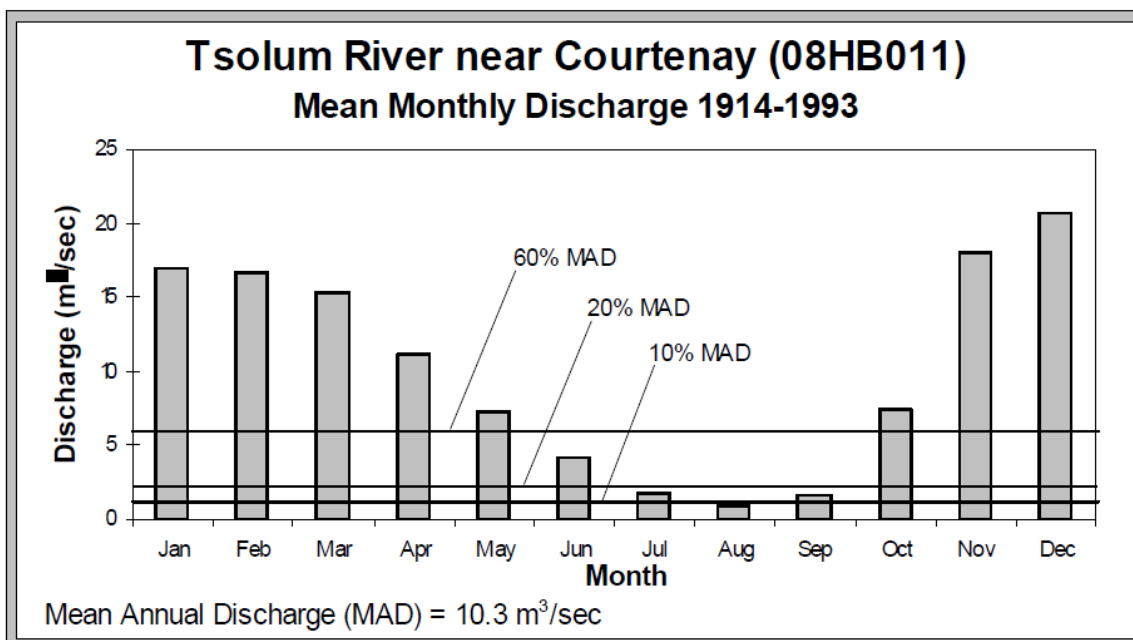
Figure 13 – Tsolum River Mean Monthly Discharge (from Water Allocation Study, Riddell & Bryden, 1996).

In 2007 Gooding described the natural un-augmented hydrology of the Tsolum as less than 5% of maximum annual discharge (MAD) and had been observed at 1% of MAD (Figure 13). The reservoir at Wolf Lake has a summer release with the goal of providing at least 10% MAD in the lower 18 km of the Tsolum mainstem during the low flow periods. The current augmentation is designed from August 15 to September 30 and is released from Wolf Lake as required to provide 30 to 35cfs downstream at WSC gauge 08HB011. The Wolf Lake weir releases water into Headquarters Creek over the summer to augment low flows and is run by the Puntledge Hatchery (DFO) according to a rule curve decided by a committee that includes the TRRS. Gooding (2007) has described additional water storage options but these are likely too costly or not feasible due to other environmental impacts.
